FIFTH QUARTERLY PROGRESS REPORT  
(May 1984 - December 1984)

DEVELOPMENT OF SAFETY CRITERIA FOR EVALUATING  
CONCRETE TIE TRACK IN THE NORTHEAST CORRIDOR  
(CONTRACT DTFR53-83-C-00009)

U.S. DEPARTMENT OF TRANSPORTATION  
FEDERAL RAILROAD ADMINISTRATION

MARCH 4, 1985

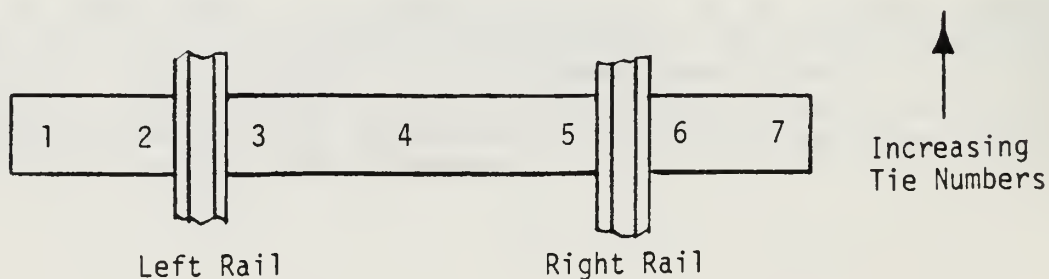
FIGURE 3. EXAMPLE OF TRACK COMPONENT FAULTS OBSERVED DURING FIRST SURVEY OF TEST SITE #1, SECTION #11

The results from all four track walker surveys for the four test sites were loaded into Battelle's BASIS data management program and verified by comparing specific track component fault occurrences with the numbers previously observed. Descriptions of the four test sites, each including between 10,475 to 15,450 concrete ties, are given in Table 1. Individual track component faults were entered for specific tie sequence numbers by the descriptive code given in Table 2. An example of the data storage format for three successive ties in Site 1 is given in Figure 2. The pattern of faults found in Survey 1 near the engine burn (EB) at Tie #33 is shown in Figure 3.

0. TIE SEQUENCE NR	9444
2. SITE NR	1
3. MILEPOST NR	67.57
4. SECTION NR	11
5. TIE NR	33
12. DEFECT LOCATION-1	2
13. DEFECT CODE-1	F0
14. SURVEY NR-1	1
16. DEFECT LOCATION-2	3
17. DEFECT CODE-2	F0
18. SURVEY NR-2	1
20. DEFECT LOCATION-3	3
21. DEFECT CODE-3	EB
22. SURVEY NR-3	1
23. DEFECT QUANTITY-3	.050

0. TIE SEQUENCE NR	9445
2. SITE NR	1
3. MILEPOST NR	67.57
4. SECTION NR	11
5. TIE NR	34
12. DEFECT LOCATION-1	2
13. DEFECT CODE-1	F0
14. SURVEY NR-1	1
16. DEFECT LOCATION-2	3
17. DEFECT CODE-2	F0
18. SURVEY NR-2	1

0. TIE SEQUENCE NR	9446
2. SITE NR	1
3. MILEPOST NR	67.57
4. SECTION NR	11
5. TIE NR	35
12. DEFECT LOCATION-1	2
13. DEFECT CODE-1	F0
14. SURVEY NR-1	1
16. DEFECT LOCATION-2	2
17. DEFECT CODE-2	FM
18. SURVEY NR-2	3
